METALS HANDBOOK

VOL. 9
FRACTOGRAPHY AND ATLAS OF FRACTOGRAPHY

8th EDITION

Fractography and Atlas of Fractographs

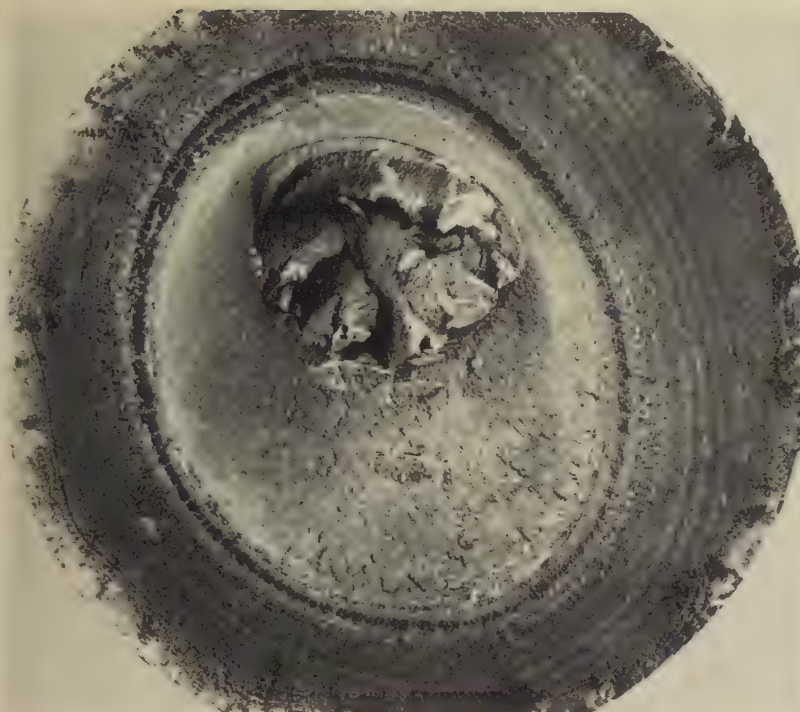
4840 Surface of a fatigue fracture in a shaft of 1040 steel with a hardness of approximately Rockwell C 30. The shaft was fractured when subjected to rotating bending. The oval shape of the central region of final, fast fracture indicates that two mutually perpendicular, unequal bending stresses were present. The ratchet marks around the perimeter of the shaft indicate that fracture began at several points.

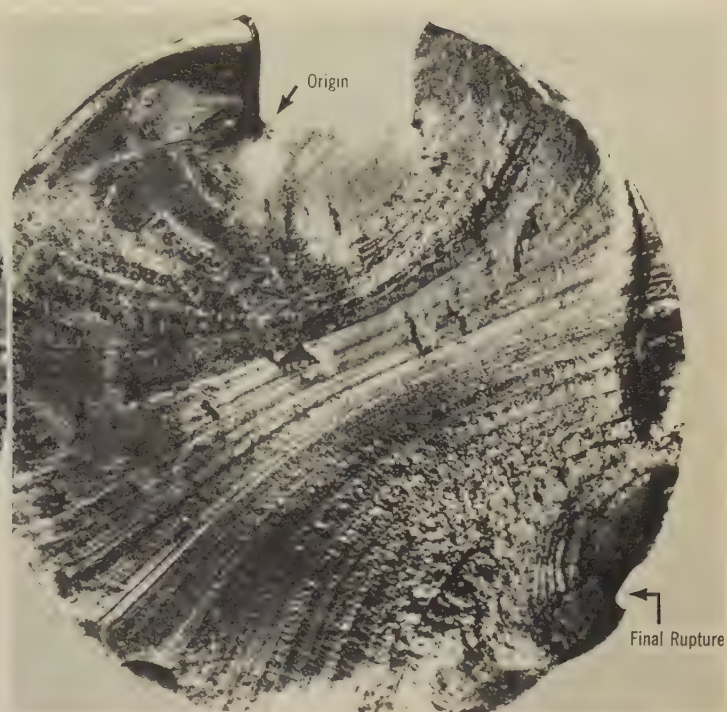
4841 Fatigue-fracture surface of a keyed shaft of 1040 steel (hardness, approximately Rockwell C 30). The fatigue crack originated at the left bottom corner of the keyway and extended almost through the entire cross section before final, fast rupture occurred. Beach marks are visible; these swing counter-clockwise because the direction of rotation was clockwise.

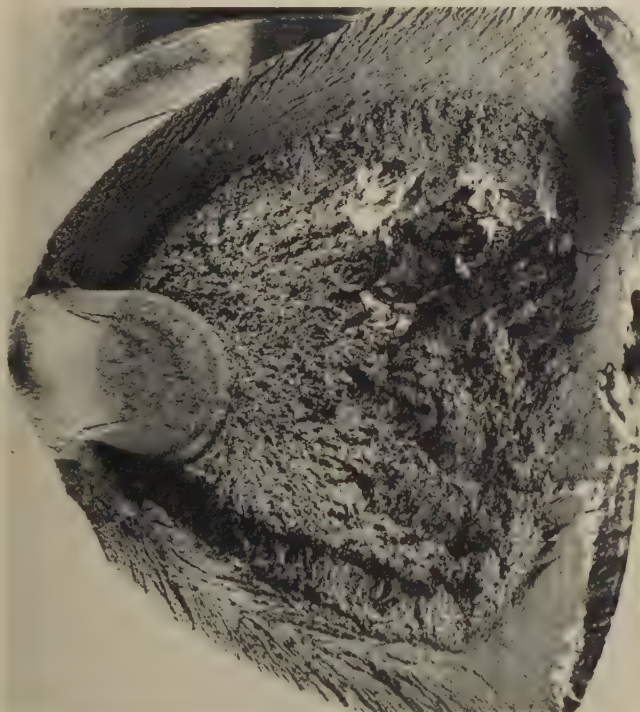
4842 Surface of a fatigue fracture in an induction hardened axle of 1041 (1541) steel with a hardness of Rockwell C 46 in the hardened zone. The fatigue crack originated at a fillet (with a radius smaller than specified) at a change in shaft diameter near a keyway runout. Note the two sets of chevron marks along the hardened perimeter, each set pointing to the crack origin at left.

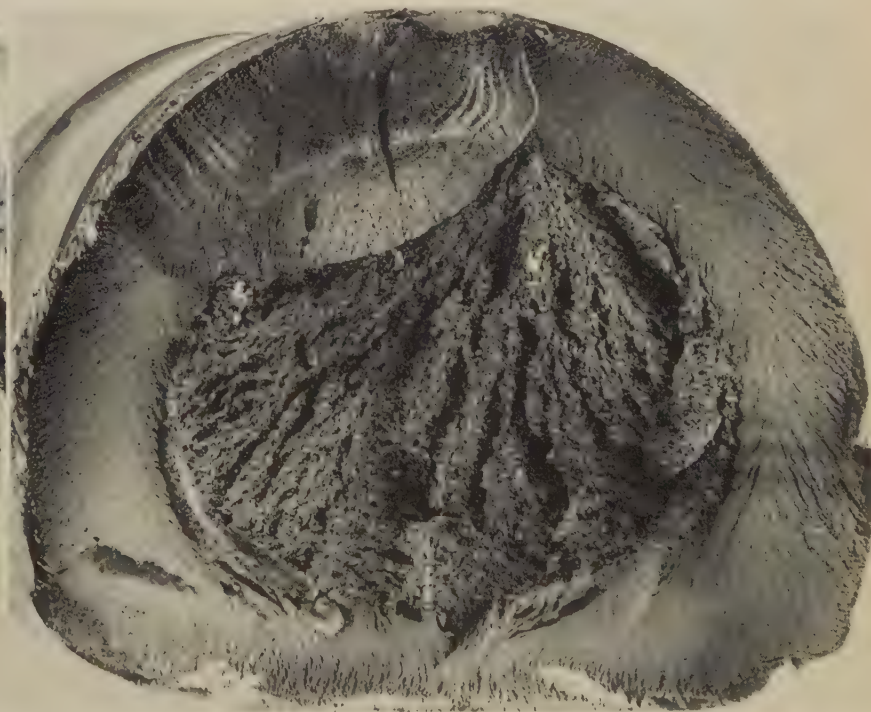
4843 Surface of a bending-plus-torsional-fatigue fracture in an experimental 3 1/2-in.-diam tractor axle of 1041 (1541) steel that had been induction hardened. Fracture occurred after 1212 hr on an endurance-test track. Note beach marks fanning out from the fatigue-crack origin (slightly to left of center, at top). Beyond the beach marks, cracking progressed by fast fracture along the hardened perimeter, producing two sets of chevron marks pointing toward the crack origin (like the chevron marks in 4842). See also fractograph 4844, on the next page.

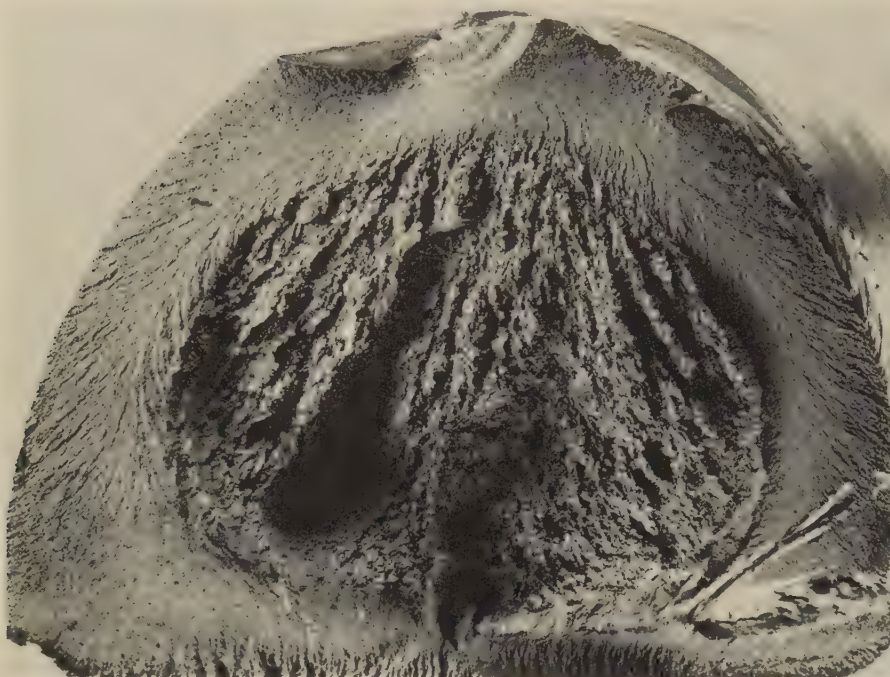
4844 Surface of a torsional-fatigue fracture in an induction hardened 1041 (1541) steel experimental tractor axle same as in 4843 (preceding page). Hardness in the hardened zone was Rockwell C 50 at $\frac{7}{16}$ to $\frac{15}{32}$ in. beneath the axle surface at the crack origin. This axle fractured after 450 hr of endurance testing. In this axle, as in the axle in 4843, crack origin is near top, at a sharp corner of a keyway runout.

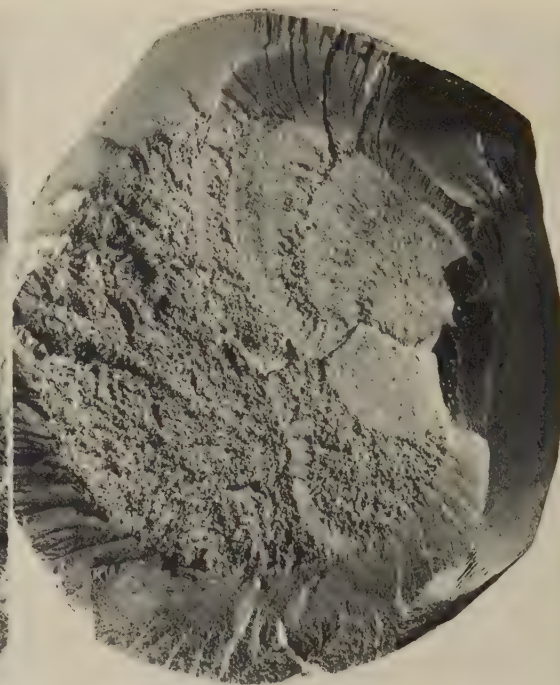
4845 Surface of a fatigue fracture in a truck axle of 1041 (1541) steel induction hardened to Rockwell C 55. The axle broke after 490 hr of service. Crack origin was subsurface, near a keyway. Note that fatigue crack progressed in steps.

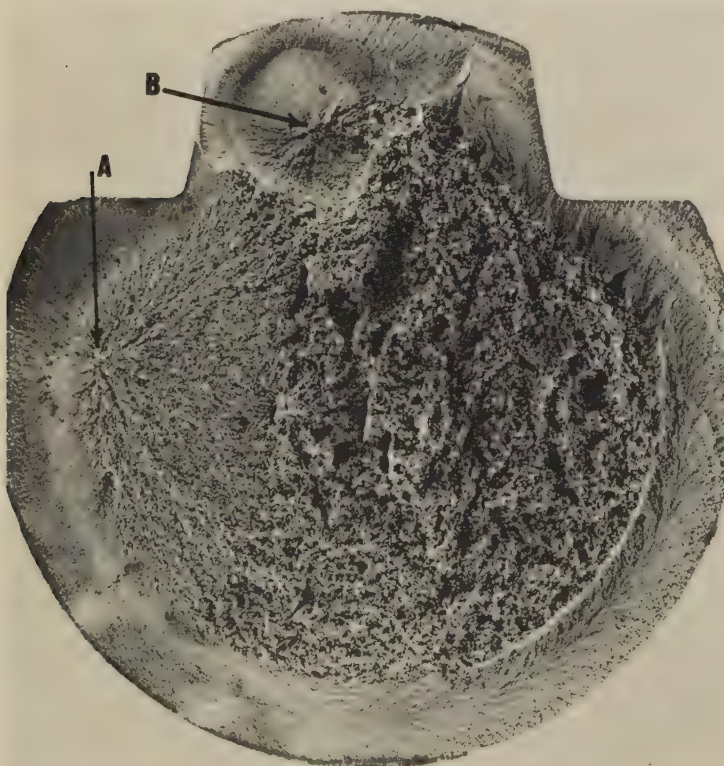
4846 Fatigue fracture in a 1041 (1541) steel axle induction hardened to Rockwell C 50 and tested in rotating bending. Two cracks are evident; one began at A and progressed around most of the perimeter by fatigue, then by fast fracture, before meeting a smaller crack, which began by fatigue at B. Chevron marks in hardened zone point to both origins. See also Fig. 10(a) on page 16.

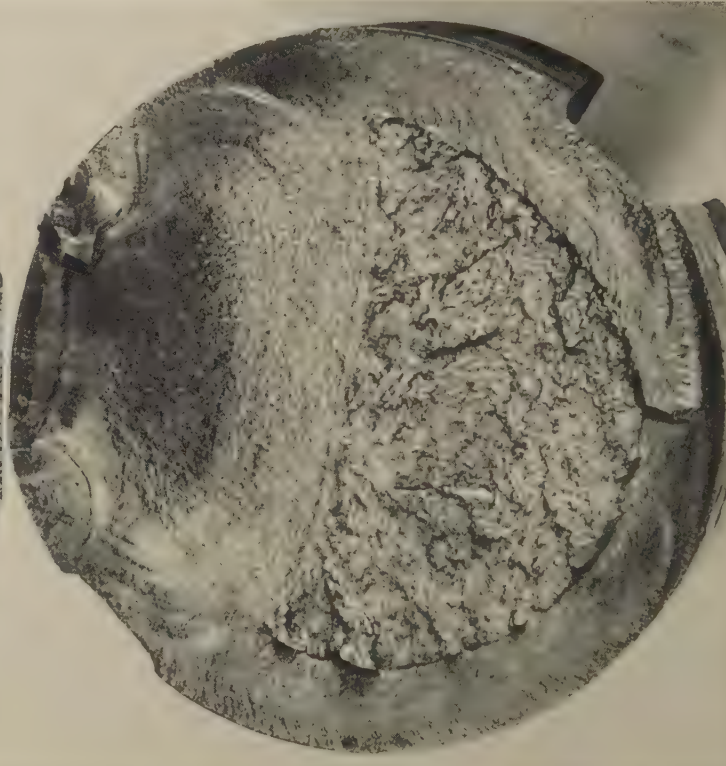
4847 Surface of a fatigue fracture in a keyed axle of 1041 (1541) steel induction hardened to Rockwell C 50. An accidental arc strike on the axle surface, at left, initiated a fatigue crack, which grew about halfway through the cross section before fast fracture occurred in the hardened zone; fast fracture progressed from both sides of the fatigue crack, as shown by chevron marks.

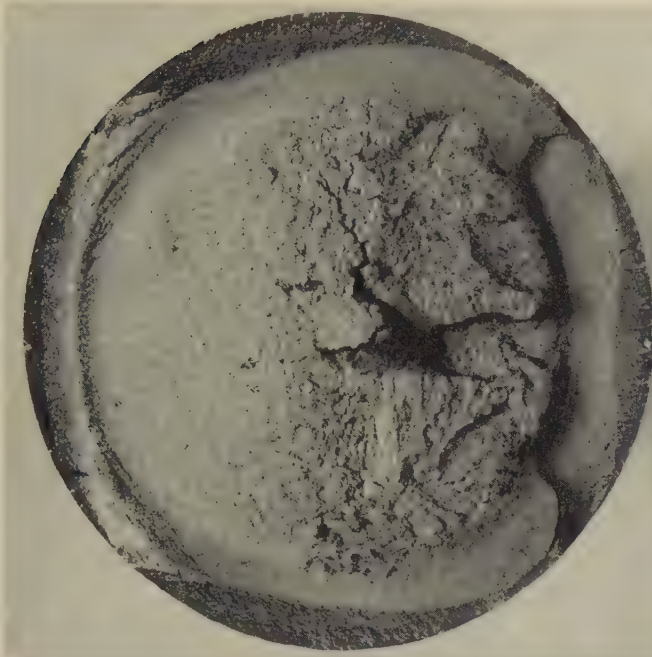
4848 Fatigue-fracture surface of a case hardened 1039 steel shaft. Case hardness, Rockwell C 50; core, Rockwell C 19. Note that fracture of the case was nearly complete before the fatigue cracks penetrated into the core.

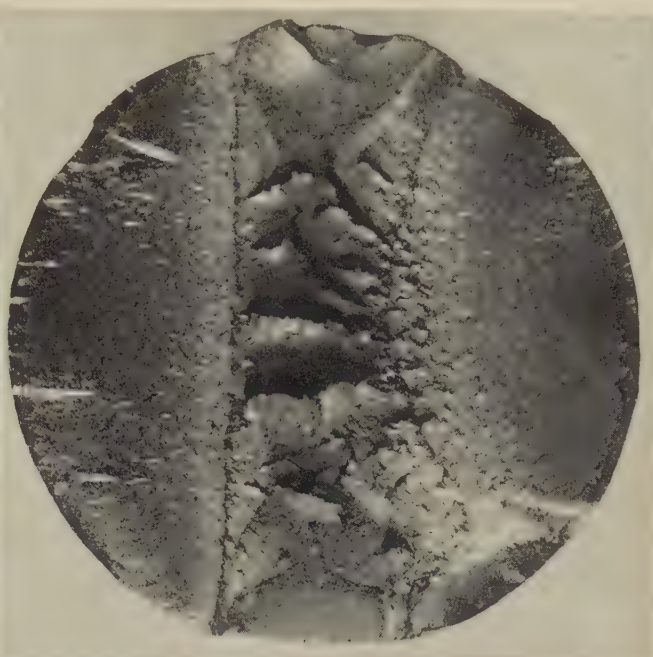
4849 Surface of a fatigue fracture in a shaft of 1041 (1541) steel with a hardness of 302 Bhn. The shaft was broken by reversed stressing. Note the two fatigue-crack origins at right edge and the third origin at left.

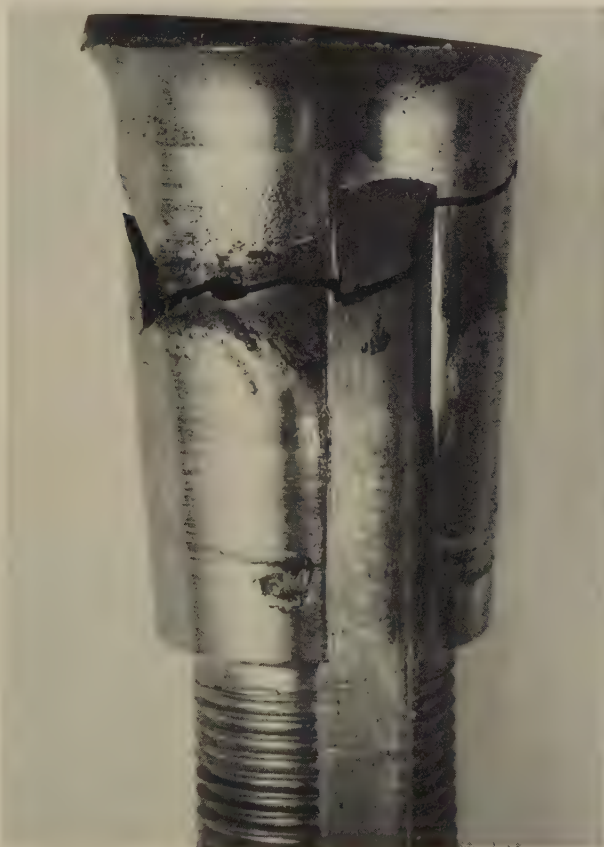
4850 View of a broken keyed spindle of 1041 (1541) steel with a hardness of 333 Bhn. A large amount of fretting is visible on both sides of the fracture. Note that the radius of the keyway edge seems small near the fracture. See also fractograph 4851.

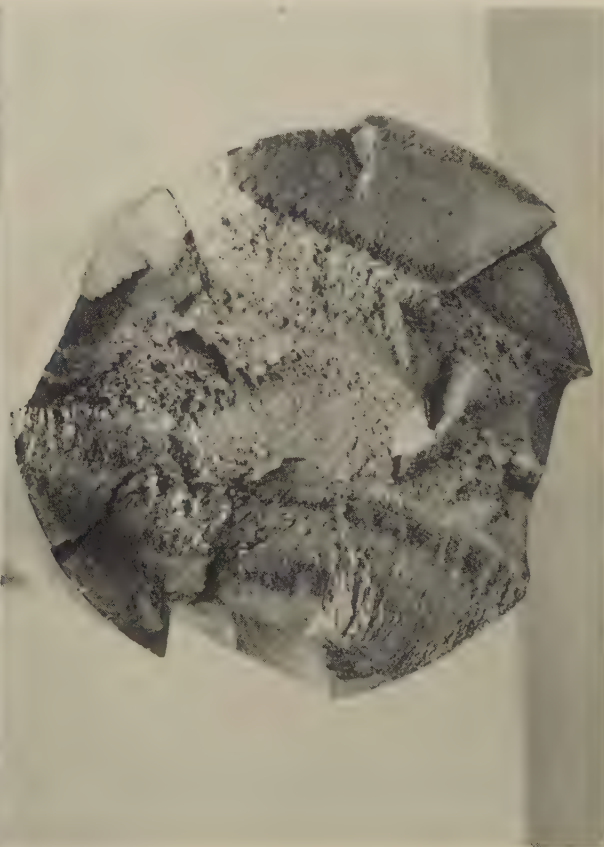
4851 Surface of the fracture in 4850 (left). Note that the radii of the keyway edges have acted as origins for fatigue cracks. A second fatigue zone is visible on the side opposite the keyway. The region between the fatigue zones underwent fast fracture.

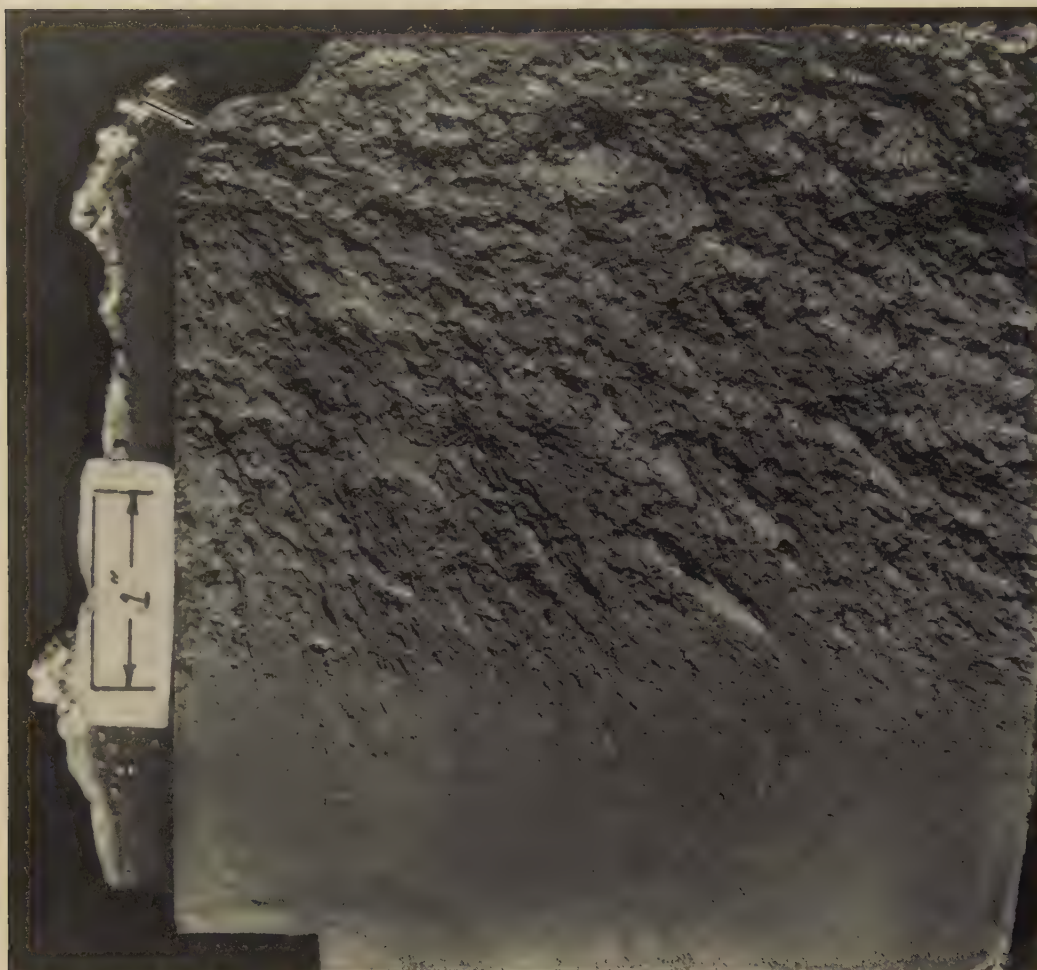
4852 Surface of a fracture in a forged pump chamber of 1038 steel normalized and tempered to a tensile strength of 530 MPa (77 ksi) and 31% elongation. Fracture originated at a radial crack (at arrow) in the plunger bore of the chamber and occurred after only 13 months of service (expected life was 4 to 6 years). Operating pressure in the chamber was 21 to 24.8 MPa (3 to 3.6 ksi). Note coarse, intergranular nature of upper two-thirds of the fracture surface, which was rubbed during propagation of the fracture into the lower portion by fatigue cracking. See also 4853 to 4855.

4853 Section taken parallel to the fracture surface in 4852, polished, and etched in equal parts of hydrochloric acid and water at 71 C (160 F). Upper portion, showing an intergranular network formed by "burning" from overheating during forging, coincides with the coarse, intergranular portion of the fracture surface in 4852. The bottom portion here is undamaged.

4854 An oblique view of the fracture surface in 4852, showing mechanical damage of the plunger-bore surface in the form of regularly spaced grooves (at arrow). It is believed that the crack originated at one of these grooves; however, in view of the marked weakness of the microstructure in the burned upper portion of the fracture surface, it appears that the fracture could have been nucleated anywhere in that portion.

4855 Polished and etched section taken longitudinally through the center of the coarse portion of the fracture surface shown in 4852 (above, left). Etchant (10 ml HNO₃, 10 ml H₂SO₄, 80 ml H₂O) reveals that burning occurred at boundaries of prior austenite grains during forging.

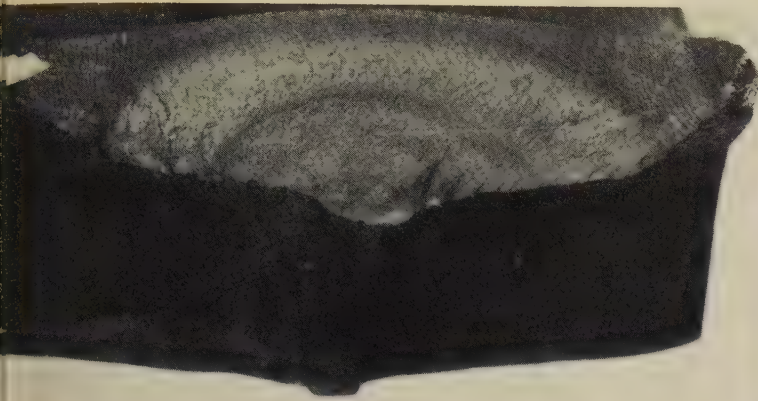
4856 Surface of a fatigue fracture in an experimental connecting rod of 1041 (1541) steel (hardness, Rockwell C 20). The fatigue crack began at bottom, at forging flash line, and penetrated nearly to the bearing surface of the rod before final fracture occurred. See 4857.

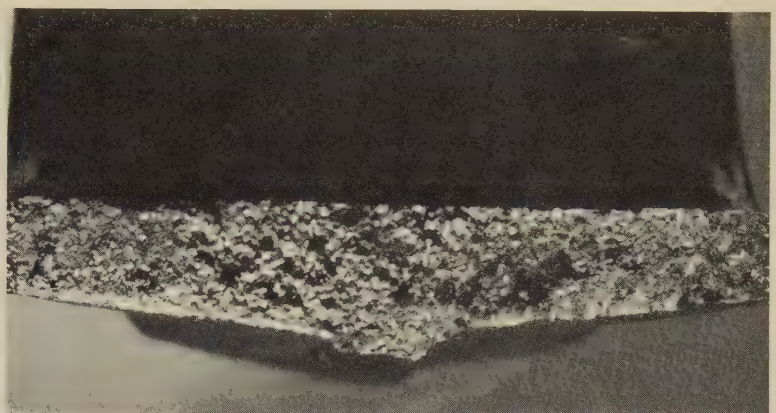
4857 Surface of a single-overload fracture in a 1041 (1541) steel experimental connecting rod similar to that in 4856. This fracture was caused when the opposite side of the bearing surface ruptured by fatigue. Note that there is no evidence of fatigue marks here.

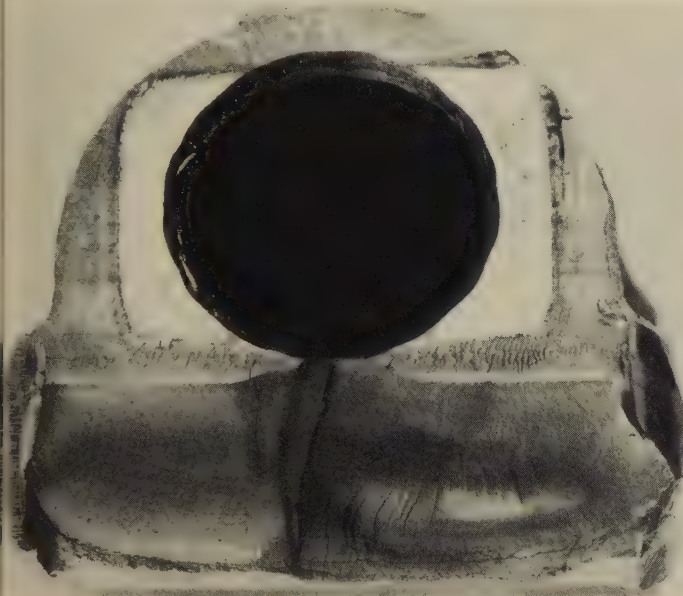
4858 Surface of a fatigue fracture near the crankshaft bearing in a 1041 (1541) steel experimental connecting rod (hardness, Rockwell C 19). Two fatigue-crack origins are near bolthole. Scuff marks in light area were made by a loose bolt.

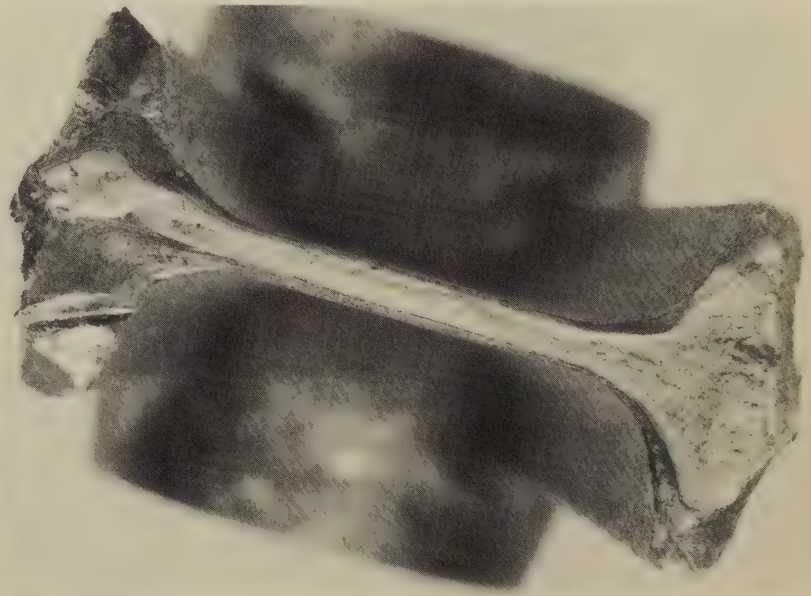
4859 Surface of a single-overload fracture in an experimental connecting rod of 1041H (1541H) steel with a hardness of Rockwell C 25 to 26. Note the shear lip, which extends almost completely around the perimeter of the fracture surface.

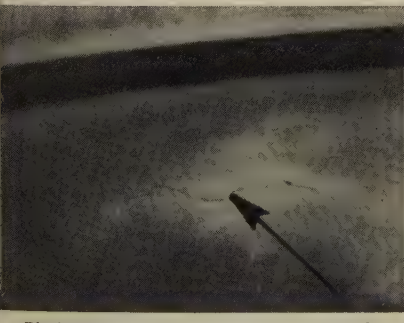
4860 Crack in a marine tailshaft of T-2 nickel steel (0.27 C, 0.67 Mn, 0.18 Si, 2.8 Ni). Crack occurred after 20 months of service; origin is at arrow. Surface appears defect-free. See 4861.

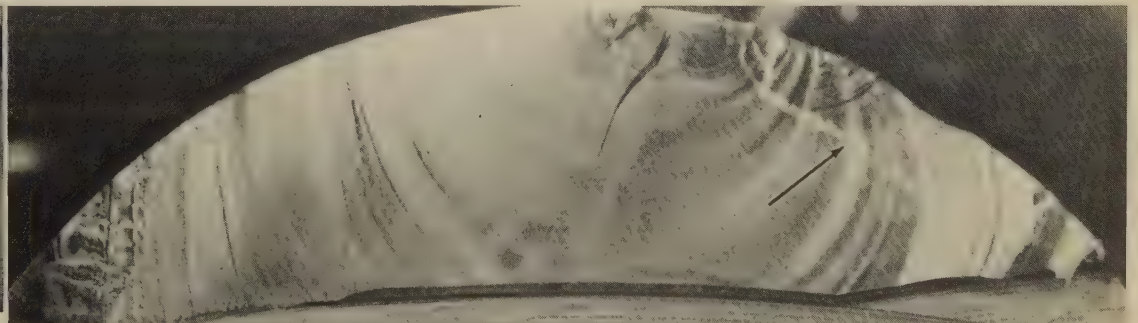
4861 Surface of the crack in 4860, exposed by sectioning, showing characteristics that are typical of fatigue. The crack had penetrated to a depth of $4\frac{1}{2}$ in. before it was discovered. The cause of the crack is not known. The external surface of the shaft visible in 4860 displays no identifiable defect. Chalk line (at arrow) indicates the location of a keyway. The stress-concentration effect of the keyway produced a level of operating stress that was higher than the endurance limit of the material.

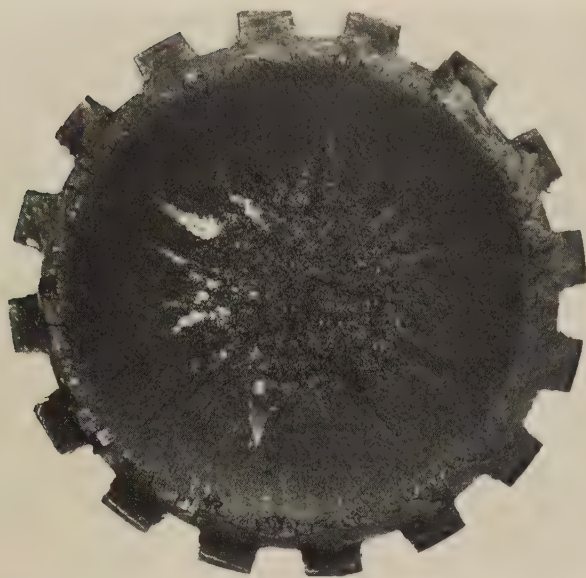
4862 Fracture surface of a large, splined axle of 10B41 (15B41) steel. Rockwell C hardness was 54 at surface, 53 at ⅓ radius and 42 at ½ radius. Fracture resulted when torsional stresses induced a circumferential fatigue crack. The axle was induction hardened to a considerable depth.

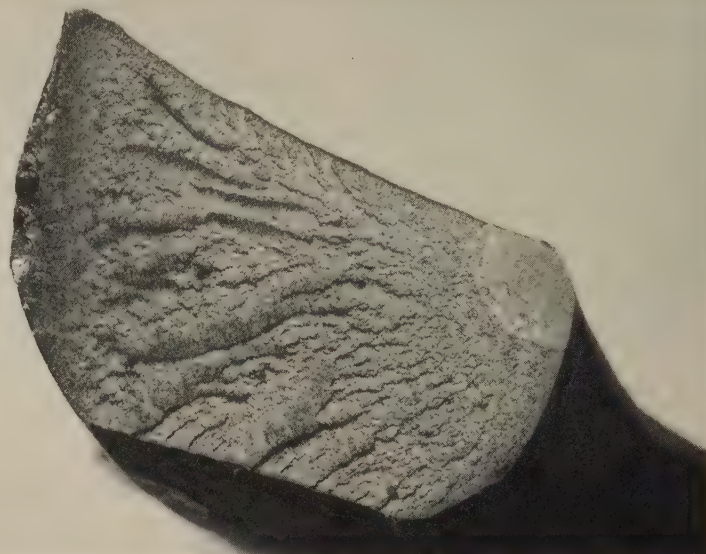
4863 Fracture surface of an experimental suspension bar of 1041 (1541) steel. The fracture origin is clearly visible in the fatigue zone at top right corner. The remainder of the fracture surface contains features that resemble cleavage river patterns.

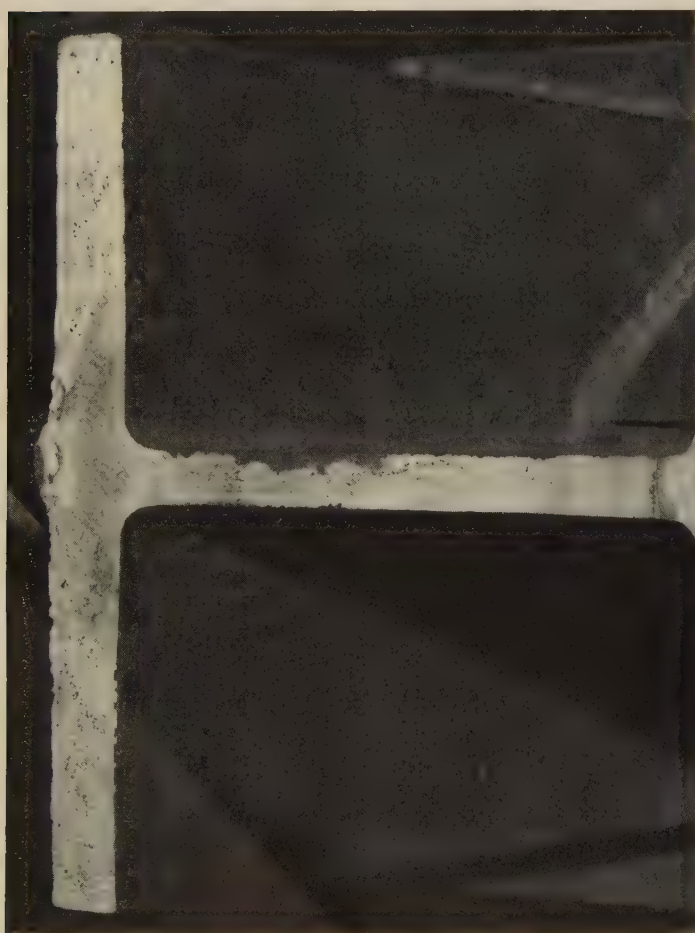
4864 Surface of a fatigue fracture in a medium-carbon steel I-beam, with a flange 15¾ by 15¾ by 1⅞ in. and a 1-in.-thick web, that was part of a dragline-excavator A-frame. Each flange of the I-beam was reinforced by a plate (such as that at right) joined to the flange by a double-pass weld. There are two fatigue-crack nuclei, separated by a cleavage step, at the toe of the weld at the outer edge of the flange at right. See also 4865 through 4867 (facing page).

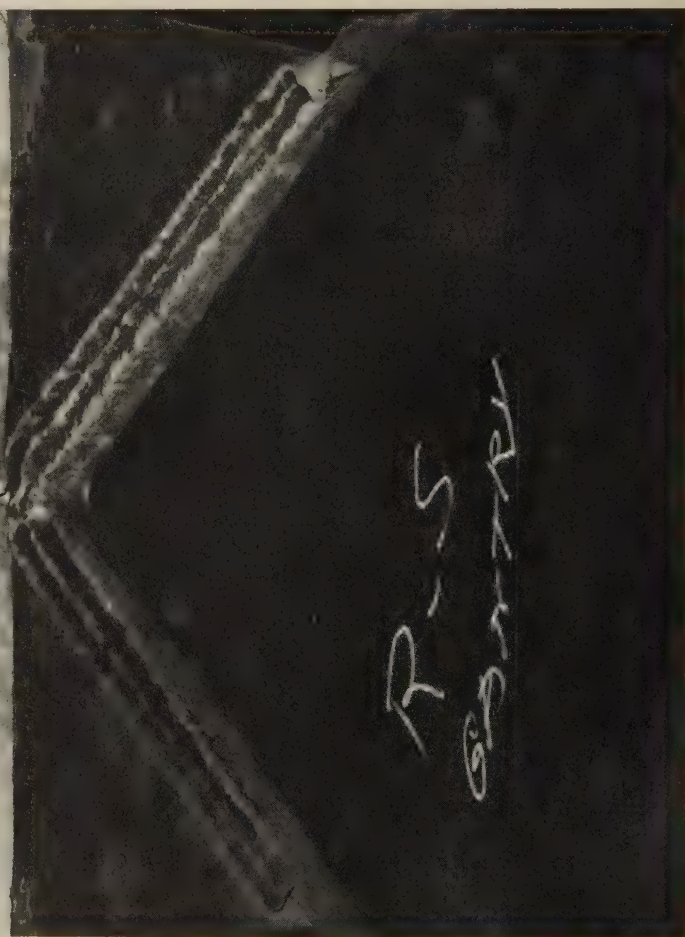
4865 Another view of the fatigue-fracture surface of the medium-carbon steel I-beam in fractograph 4864 (on preceding page). The fracture origins are clearly evident in the flange at bottom, where two nuclei are situated at the toe of the weld joining a reinforcement plate to the flange. It is remarkable that the fatigue crack penetrated the entire flange at bottom, the entire web, and part of the flange at top before final, fast fracture occurred. See also fractograph 4866 and micrograph 4867, at left and right above.

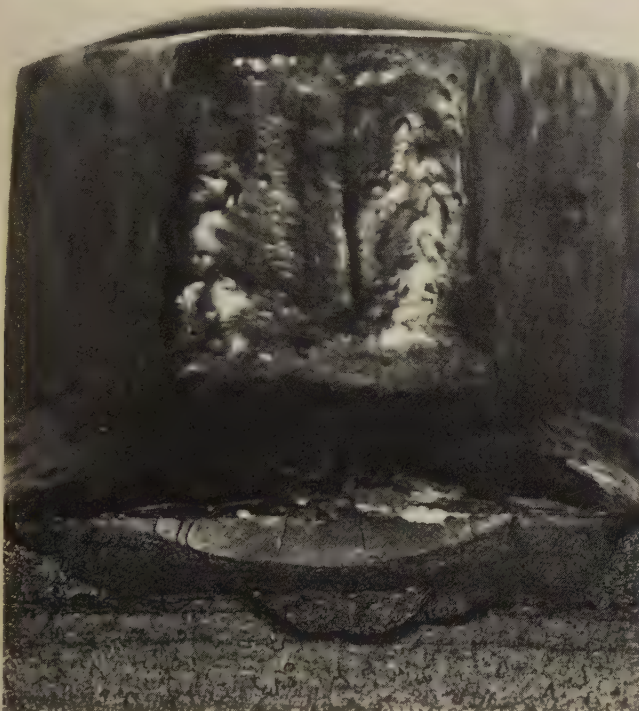
4866 A view of the weld joining the flange and reinforcement plate at top in 4865, showing a crack at the toe of the weld. This crack was present before the fatigue crack, which led to fracture, formed at the toe of the weld in the other flange. See also 4867, at right.

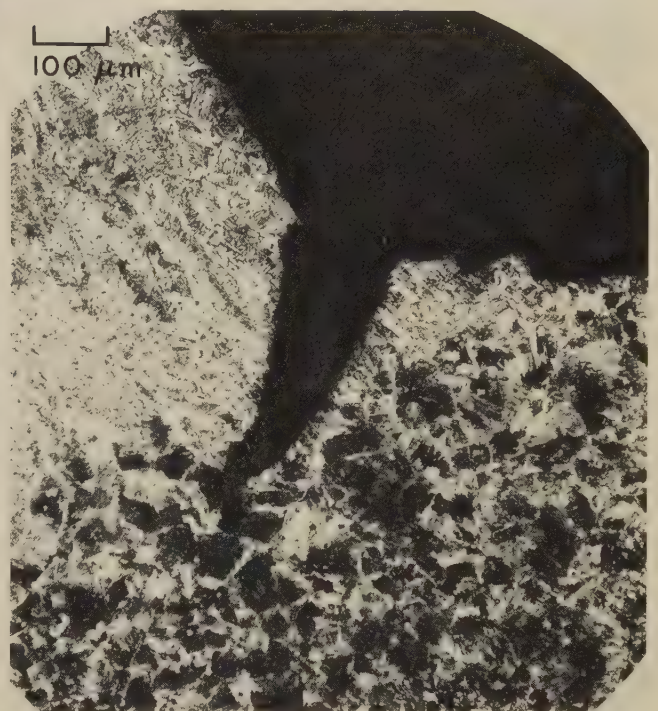
4867 A polished and etched section through the weld in 4866, at a position just to the left of the area shown there. Like that in 4866, the crack shown here was present prior to formation of the fatigue crack in the opposing flange. The weld metal (light) is at upper left.

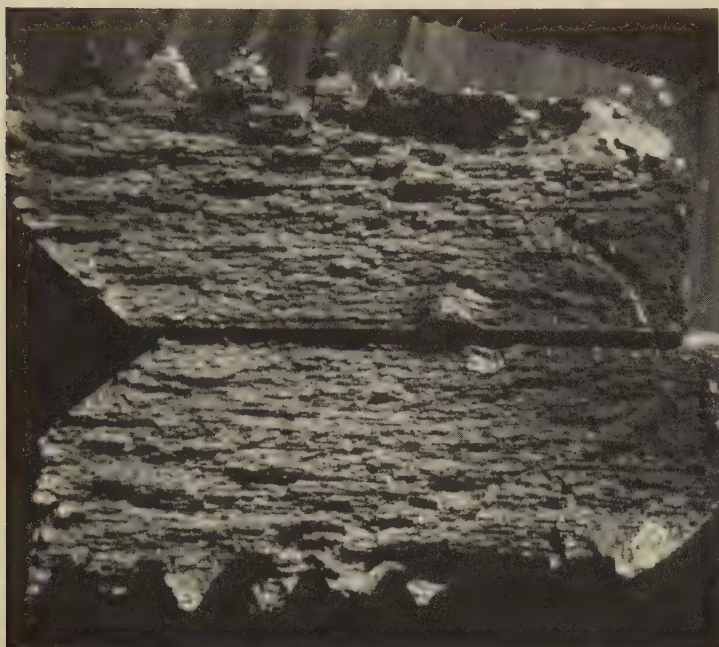
4868 Mating surfaces of a fracture in a stud nut that was machined from 11L40 steel (0.15% Pb) heat treated to a hardness of Rockwell C 31 to 32. Note the very woody nature of the fracture surfaces, which is a result of adding lead to improve the machinability of the steel.

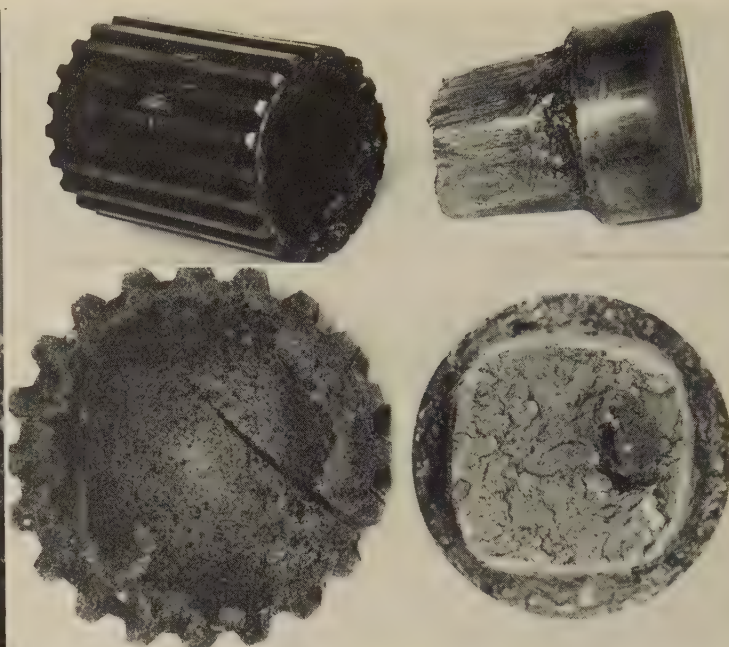
4869 At top (4869) is a "tapered plug" fracture in a splined idler shaft of 1144 steel containing 0.33% S. At bottom (4870) are sections, heavily etched in warm hydrochloric acid, through both the bearing and spline ends of the shaft; patterns of light and dark etching here suggest alloy segregation.

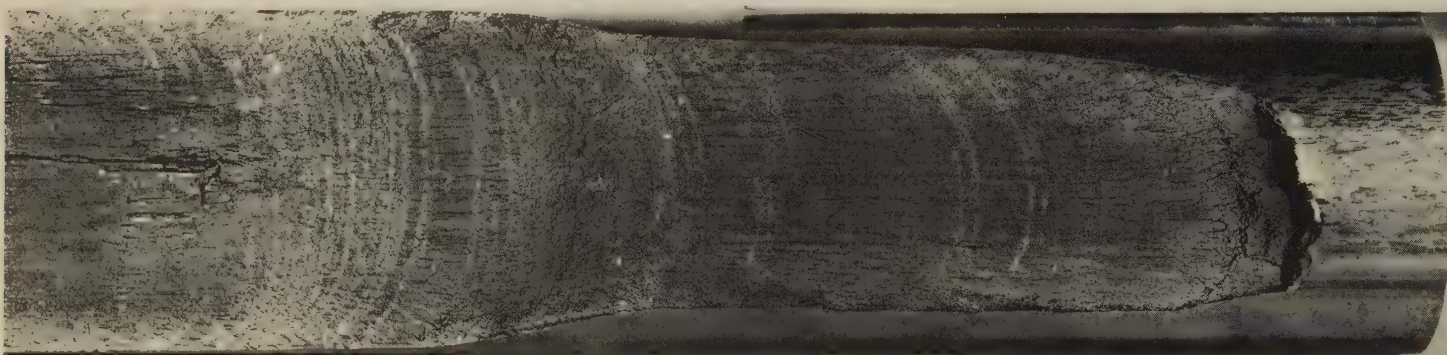
4871 Fatigue-fracture surface of the shaft of a forging hammer of 1144 steel containing 0.45% C, 1.60% Mn and 0.28% S. The fatigue crack began at a heavily abraded surface area (out of view to the left), penetrated to the center of the shaft, then turned 90° and propagated longitudinally to the point of termination at right (about 25 in.). See also 4872.

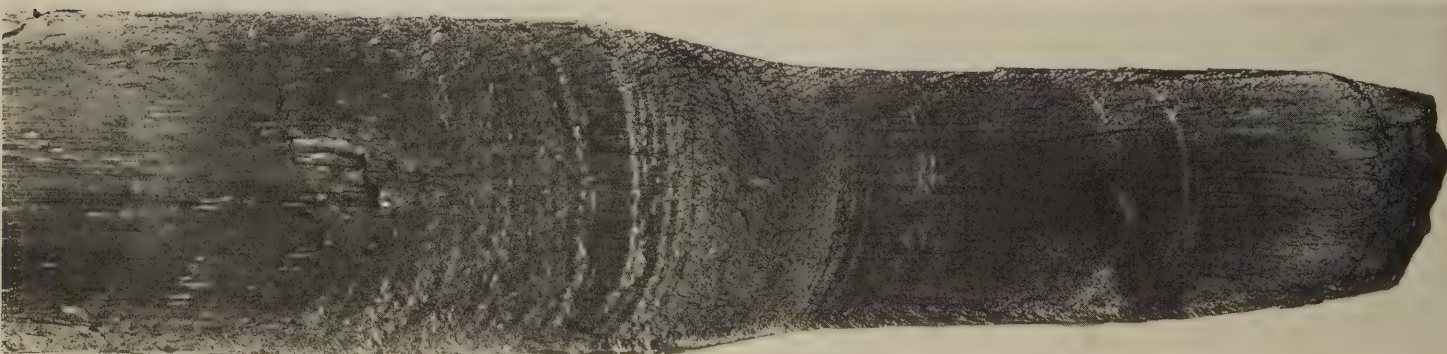
4872 Mating fracture surface to the one shown in fractograph 4871 (above). This piece of the shaft broke away during service. It is believed that the crack propagated a long distance in the longitudinal direction because of weaknesses associated with the presence of longitudinal bands of elongated manganese sulfide inclusions.

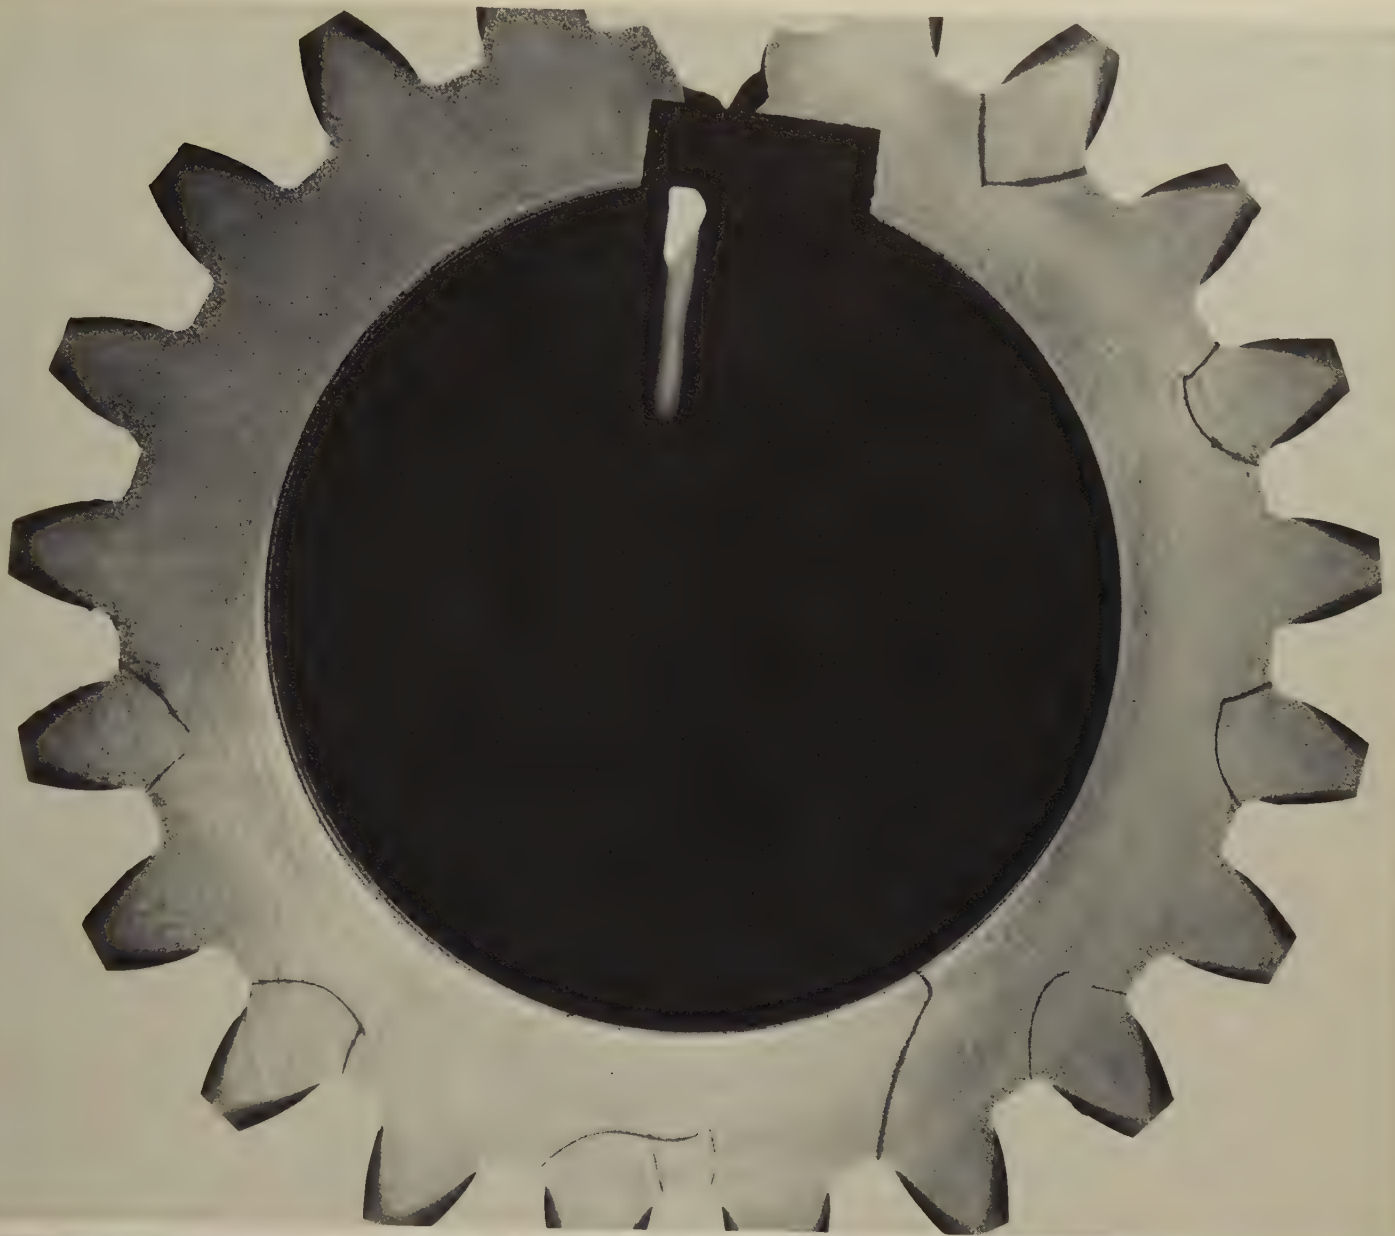
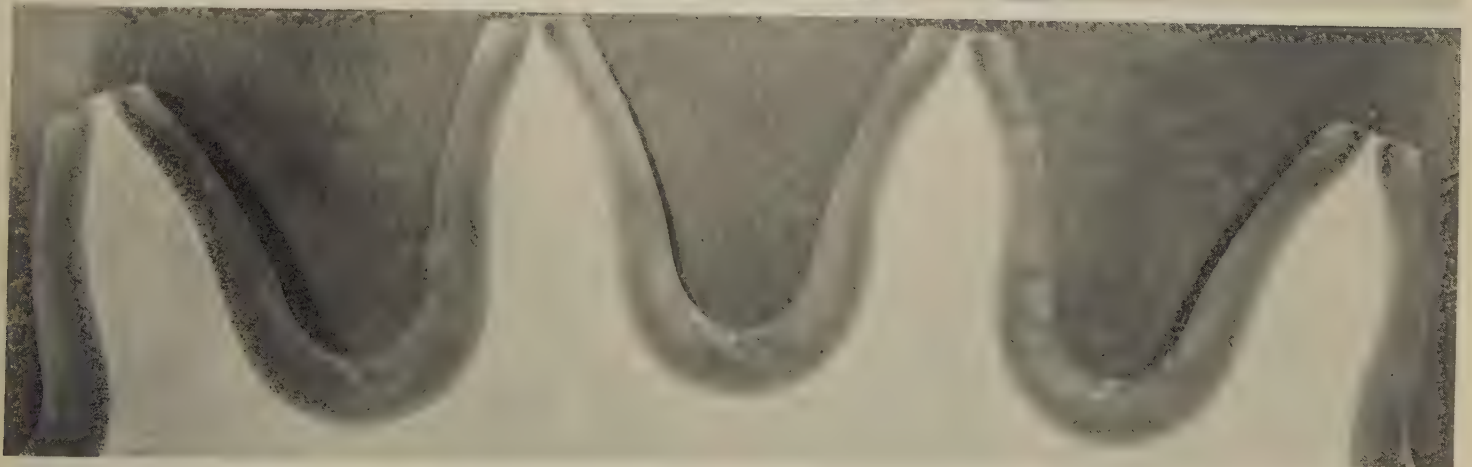
- 4873 At top (4873) is a polished and etched cross section of a partially flame hardened crane gear of 1045 steel in which fatigue cracks formed at the roots of many teeth after one year of service. The cracks have been sharply delineated by etching. Note that hardening did not extend even to the root fillet of any tooth. At bottom (4874) is a polished and etched cross section of a portion of a gear that was subjected to full-contour flame hardening; note the better tooth form, with fully radiused tooth roots.
- 4874

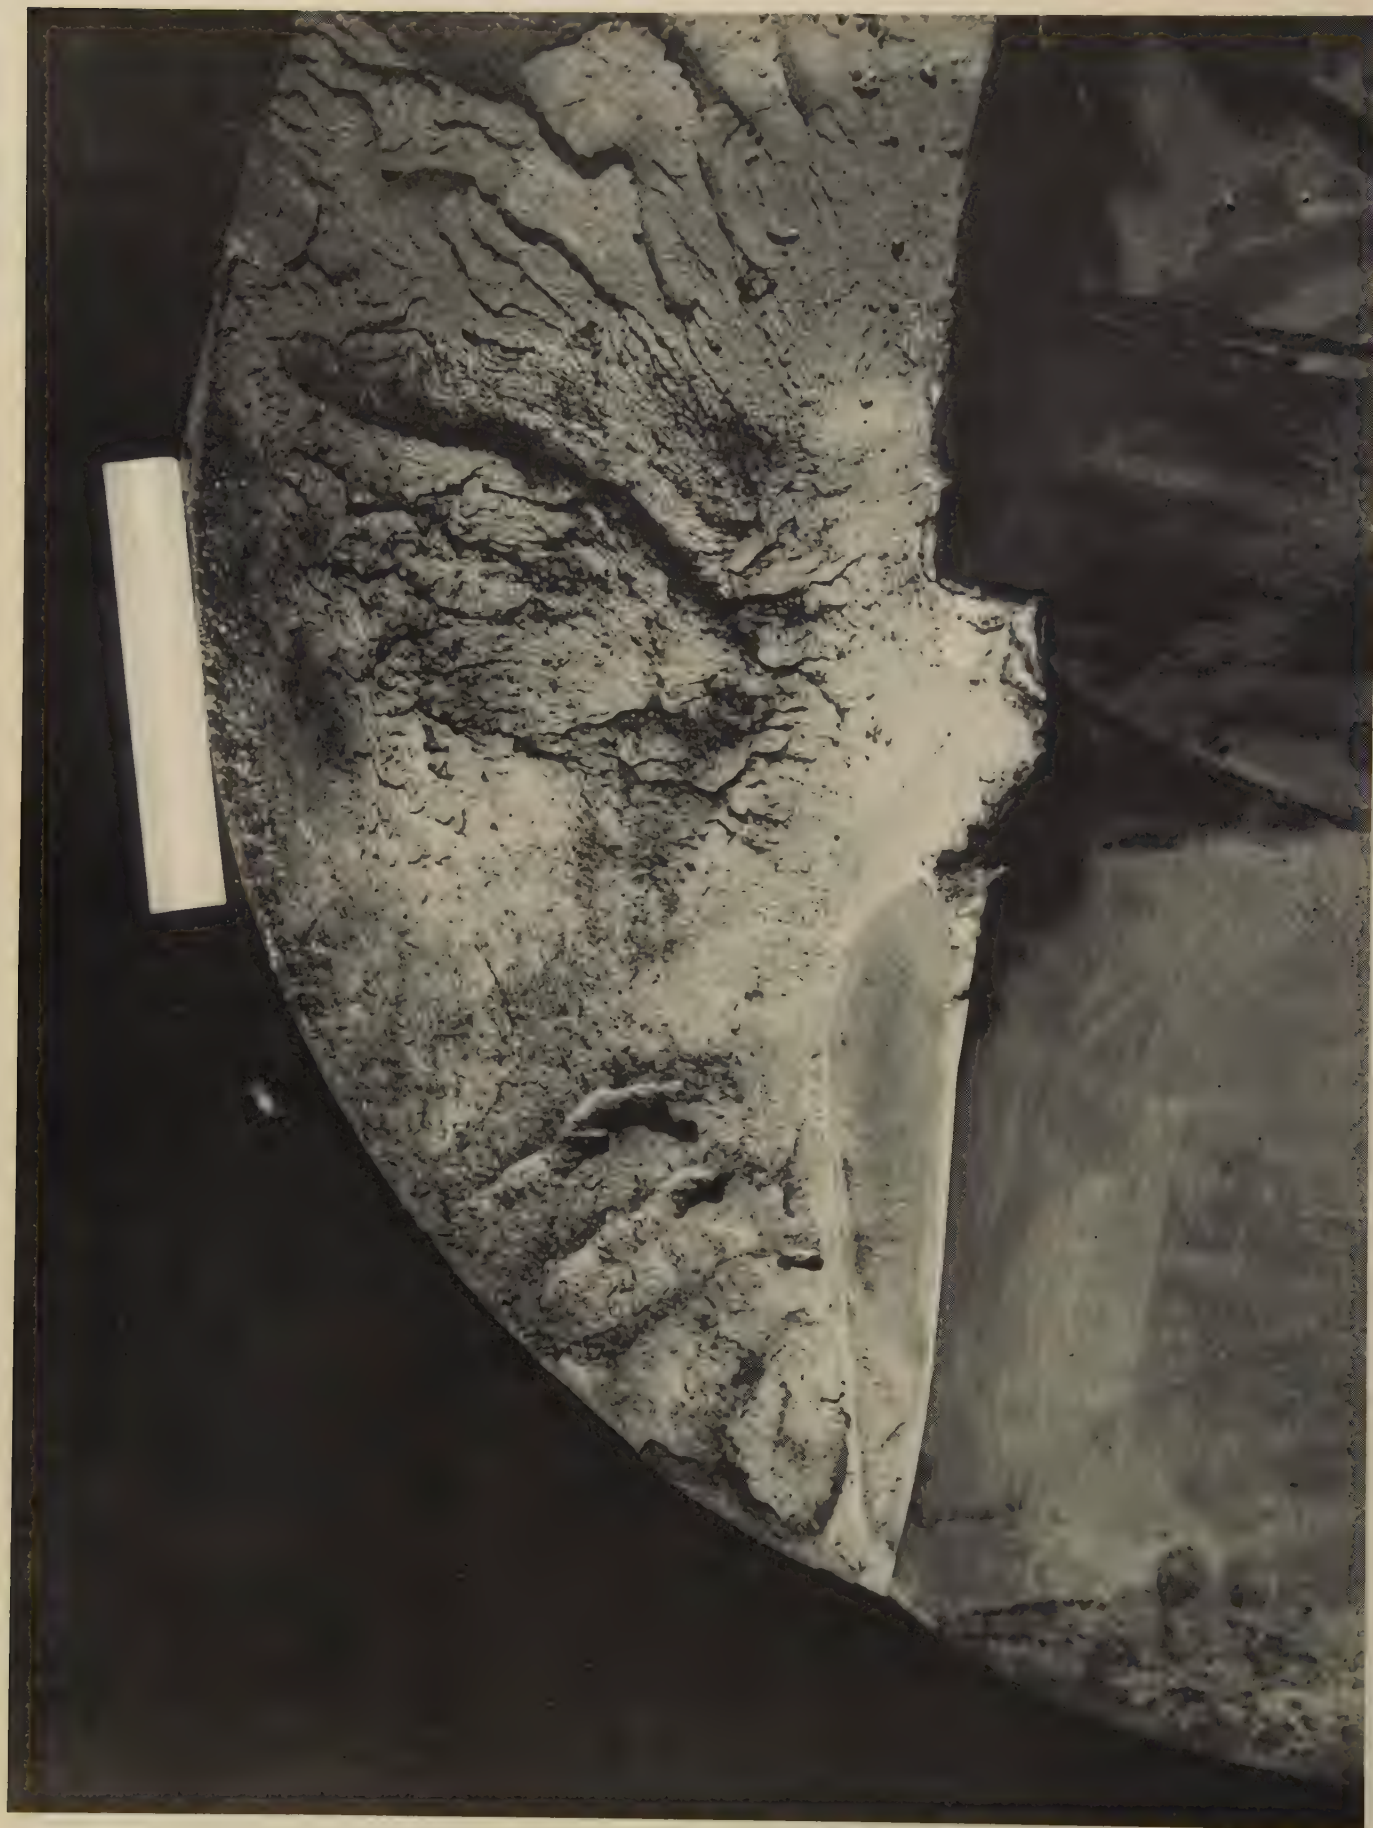
0.4 ×
4875 A fracture surface in the jaw end of a blooming-mill spindle of forged 1045 steel. This spindle was 27 ft long, 35 in. in diameter at the jaw end, and 42 in. in diameter at the drive end. The white six-inch rule at top indicates the massive size of the spindle. After the spindle had been normalized, the inner surface of the jaw was flame hardened. The fracture originated at the jaw surface, at the lower edge of the fatigue zone (left of center). See also fractograph 4876 (on facing page).
